SHENANDOAH COUNTY

**FEASIBILITY ANALYSIS OF
RENOVATION AND EXPANSION OF SHENANDOAH COUNTY COURTHOUSE
AS PROPOSED BY CITIZENS FOR DOWNTOWN COURTS**

June 18, 2007

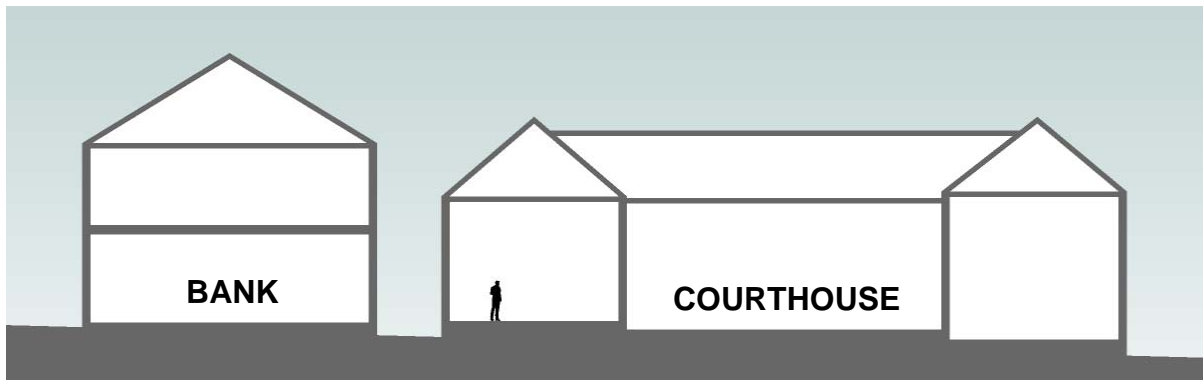
Diagram A

The original Courthouse fronting on Main Street (at right in diagram) was constructed in the 1790's. The middle portion (current courtroom) was added in 1871, and the rear portion (current clerk's office) in 1880. As the diagram indicates, the Courthouse first floor actually consists of three different floor levels. Apparently this results from the fact that the Courthouse property slopes gently upward from Main Street toward the Bank, so each of the two additions to the original Courthouse has a correspondingly higher floor. The difference in elevation between adjacent floors is less than two feet in both cases.

The first floor of the Bank building is between two and three inches lower than the first floor of the adjacent 1880 courthouse wing. Since the two floors are at nearly the same level, connecting them together would be relatively simple assuming that the level of the adjacent Courthouse floor is not altered.

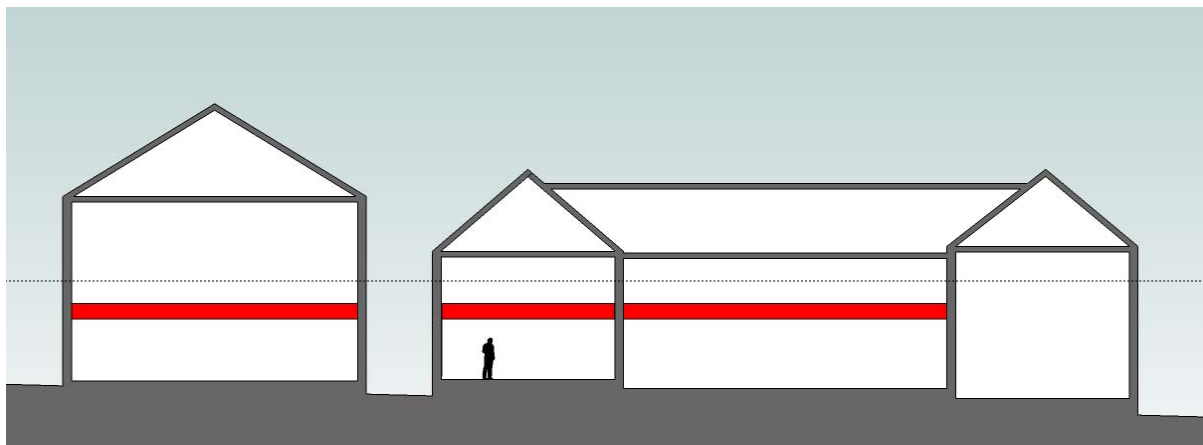
Diagram B illustrates the proposed construction of a new second floor in the Courthouse. Proposed new construction is indicated in red. The dashed line indicates the elevation of the existing second floor in the Bank. Height limitations in the Courthouse will prevent its new second floor from being constructed to align with the existing second floor of the Bank. CDC thus proposes removal of the existing second floor of the Bank and construction of a new one at a lower elevation. This new floor is also shown in red. The diagram does not indicate alterations to the roof structure of the Courthouse that would be necessary to achieve adequate headroom for the new second floor. That issue is addressed below.

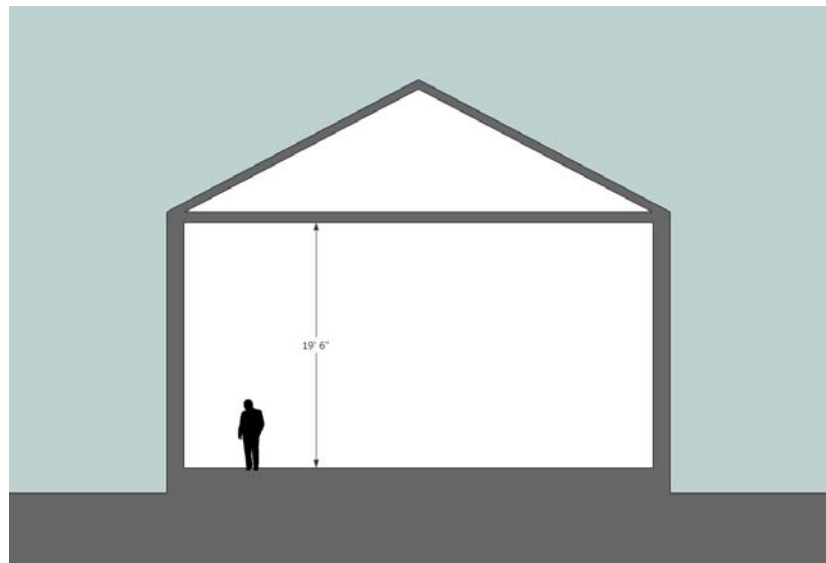
Diagram C shows a cross-section of the 1871 center portion of the existing Courthouse at the courtroom.

The height from the existing courtroom floor to the bottom of the lower tie beam of the roof truss is about 19'-6". (The ceiling height is actually lower, but the ceiling is suspended from the roof structure and can be removed with no impact on the structure.) Hal Craddock's letter of May 18, 2007, to Vince Poling proposes constructing the new second floor of the Courthouse at a height of eleven feet above the first floor of the rear wing of the building. This would place it about 12'-4"

above the first floor of the center portion of the building since the first floor in that part of the building is about 1'-4" lower than the first floor of the rear wing (see Diagram B).

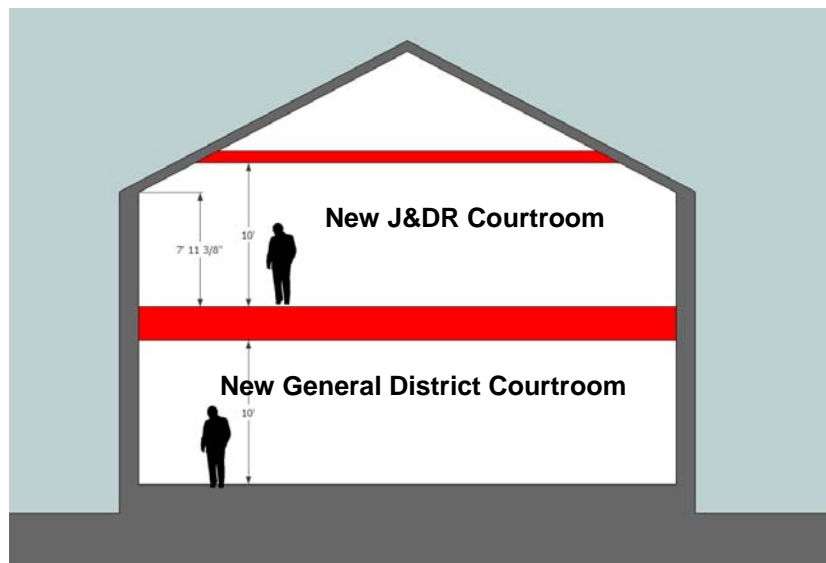
As Diagram D indicates, a ceiling height of ten feet can be achieved in the new second floor courtroom over part of the room, but the slope of the roof will reduce the height of the ceiling

to less than ten feet over about twenty percent of the room, and to less than eight feet at the exterior walls. Nevertheless, the symmetrical configuration of the sloped ceilings along the sides of the room may be compatible with the proposed courtroom use even though a minimum height of ten feet would not be maintained throughout the entire space.
